MISSION STATUS BULLETIN

VOYAGER

April 7, 1978

No. 18

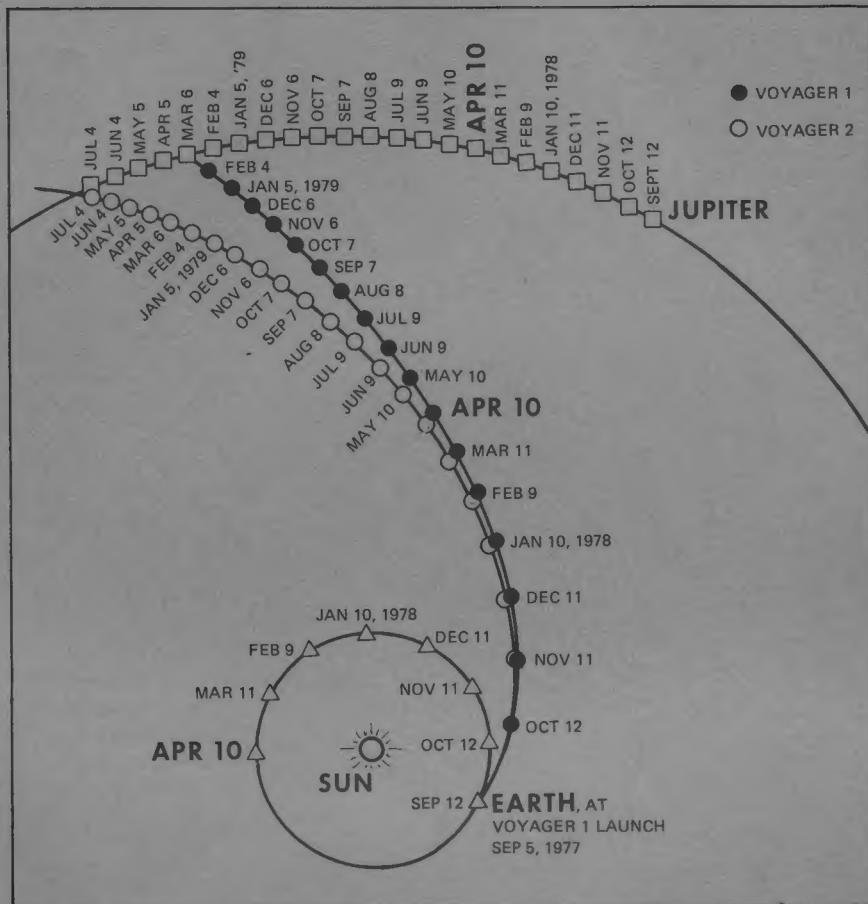
Communications

Voyager 2's main radio receiver appears to have failed, and the backup receiver may have a faulty tracking loop capacitor which might make communications with the beleaguered ship extremely sensitive.

On April 5, the computer command subsystem entered a protection sequence which switched the craft from the primary receiver to the secondary receiver since no command had been received in seven days. Attempts to attain two-way lock on the secondary receiver failed and diagnostic tests executed after the switch to this unit indicated a problem with its tracking loop capacitor. The protection sequence is programmed to switch back to the primary receiver if the secondary unit receives no commands in the following twelve hours. Since attempts to attain two-way lock on the second receiver failed, the program switched back to the main receiver.

After this switch, operations appeared normal and several commands were transmitted through the main receiver, thus causing a reset of the seven-day timer. However, about 30 minutes after the switch, an unknown failure in the receiver caused excessive current which appears to have blown the receiver fuses.

The spacecraft remains configured on the main receiver and unable to receive commands from Earth. However, the seven-day timer will automatically switch to the secondary receiver on April 13, at which time attempts will be made to command the spacecraft in spite of the failed capacitor.
